**Post-Occupancy Management of Condominiums and Roles of Unit Owners' Associations in Akaki-Kaliti Sub-City, Addis Ababa****Tesfaye Teshome Gessesse**

**ABSTRACT**

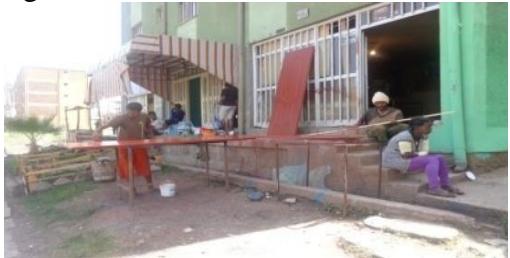
Figure 1: Wood and Metal Workshop   Figure 2: Partial View of Satellite Dishes  
Fixed on Condominium Buildings

On the other hand, 24.6 percent of the residents keep pets violating Article 13, sub-article 1 of the Owners Association bylaws. As indicated in Fig.-1, the presence of wood and metal workshop signifies incompatible uses that harm the safety and health of the residents in a purely residential apartment besides violating the regulations. Fixing satellite dishes on buildings is also a common problem in all sites disregarding article 7, sub-article 5 of the regulations (see Fig.-2).

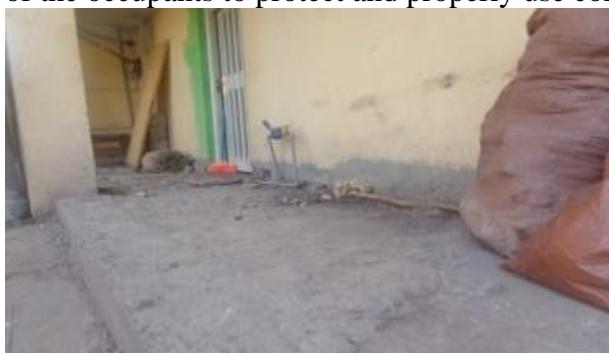
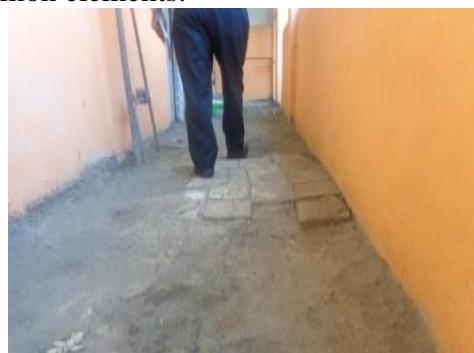
Based on the nature of the common elements two aspects were identified. They are in-door and outdoor common elements. The pictures taken during the field survey depict damages inflicted by the occupants (Figs.-3), structural damages due to poor construction capacity and geological or inappropriate site selection (Fig. 4). The photographs in Fig. 3 clearly show reluctance of the occupants and the management regarding the proper use of the corridor an important part of the indoor common elements. The deliberate removal of the tiles causes a physical damage on the building and is against the regulation that provides for the protection of common elements by all residents. According to article 27, sub-article 2 of Proclamation No.370/2003 it is the responsibility of the unit owner's association to maintain proper use of common elements. But the management of the association is found to be passive unable to stop such wrong and distractive actions of some occupants. The response rate of households i.e. 36.4 percent (Table 2) proves the reluctance of the occupants to protect and properly use common elements.

Figure- 3: Dilapidated Corridor, Floor Tiles are Removed,

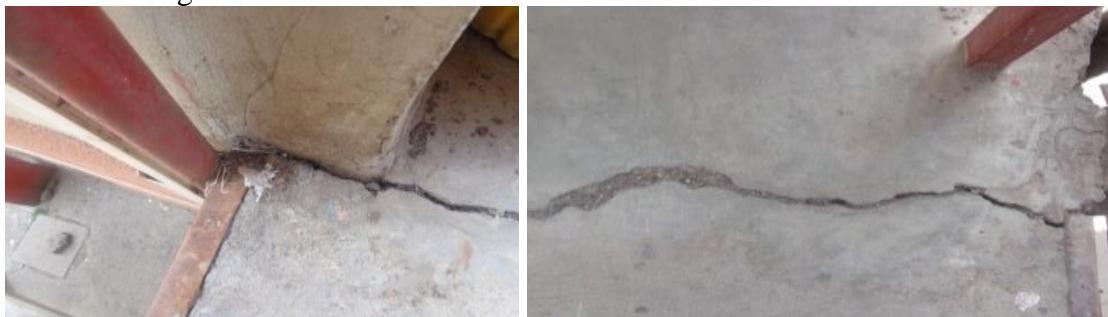
The structural damage due to poor construction as shown in Fig.-4, the cracks on the staircase that connects two adjacent blocks was getting wider and detaching from one of the blocks. The problem remains a threat to all up-stair occupants. Although the maintenance of the common elements was the responsibility of the owners ‘association as stated in the proclamation, the condition of the buildings in the pictures proves it is beyond the capacity of the management. Fig.-5 indicates the most serious post-occupancy problem discovered associated with inappropriate site selection. The twin photographs both side and front views show water emerging from underground (spring water) or from the basement of one of the condominium blocks. This condition violates the provisions stated in UN-Habitat (2004 & 2009), Goal 1 Indicator 1.1 & Goal 11, Indicator 3.8 ‘durable structures’ and ‘hazardous location’. Both Agendas call for the promotion of the right to adequate housing implying that housing units considered as ‘durable’, i.e. built on a nonhazardous locations. However, as indicated in both pictures, while this study was being conducted, the location of one of the condominium blocks was exactly in geologically hazardous area proving a failure to meet the Habitat Agenda.

Figure - 4: Cracks on Stair Case Joint between two Adjacent Condominium Blocks

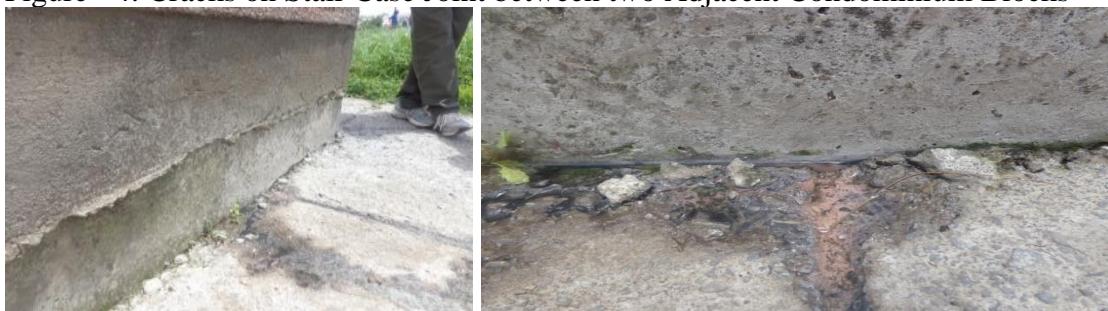
Side View (i)

Front View (ii)

Figure -5: View of Underground Water Leaking out from the Basement of a Condominium Block

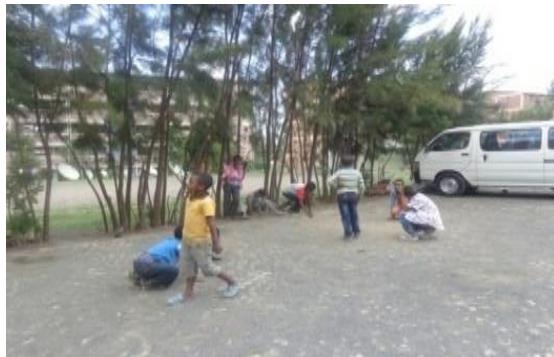
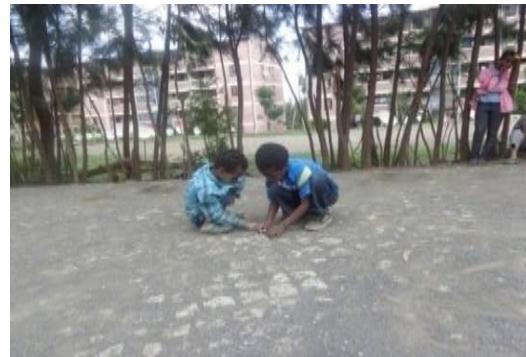
not clearly identified and facilitated for the desired objectives. In all sites where this study was conducted, the available open spaces were largely covered by cobblestone and boys were forced to share these open spaces for playing games with cars around them (Fig.-6).

i) Mixed Use

ii) Lack of a Proper Playing Ground

Figure - 6: Mixed Use of Playing Ground and Car Parking

There must be a regular program to enhance proper awareness of bylaws and regulations of condominium housing to the occupants. This would help to reduce problems resulting from reluctance and failure to comply with rules and regulations. Maintain proper playground for children, improve unhealthy neighborhood environment by introducing proper liquid waste disposal and stop random disposal of solid waste. Build management capacity: a capacity building program definitely enables leaders of unit owners' associations to properly execute their powers and duties as stipulated in the Proclamation N0.370/2003 and bylaws. Plan to achieve strong social cohesion: Above all, a strong social cohesion promotes coexistence and cooperation among people with different social, economic, ethnic, religious and educational backgrounds. Introduce effective property and safety protection system: To mitigate typical problems such as theft fence the compounds with permanent structures and encourage the employed guards to give due attention to properties found in the compound. In order to achieve healthy urban development, integrated multi-disciplinary housing development approach need to be employed to avoid post occupation problems.

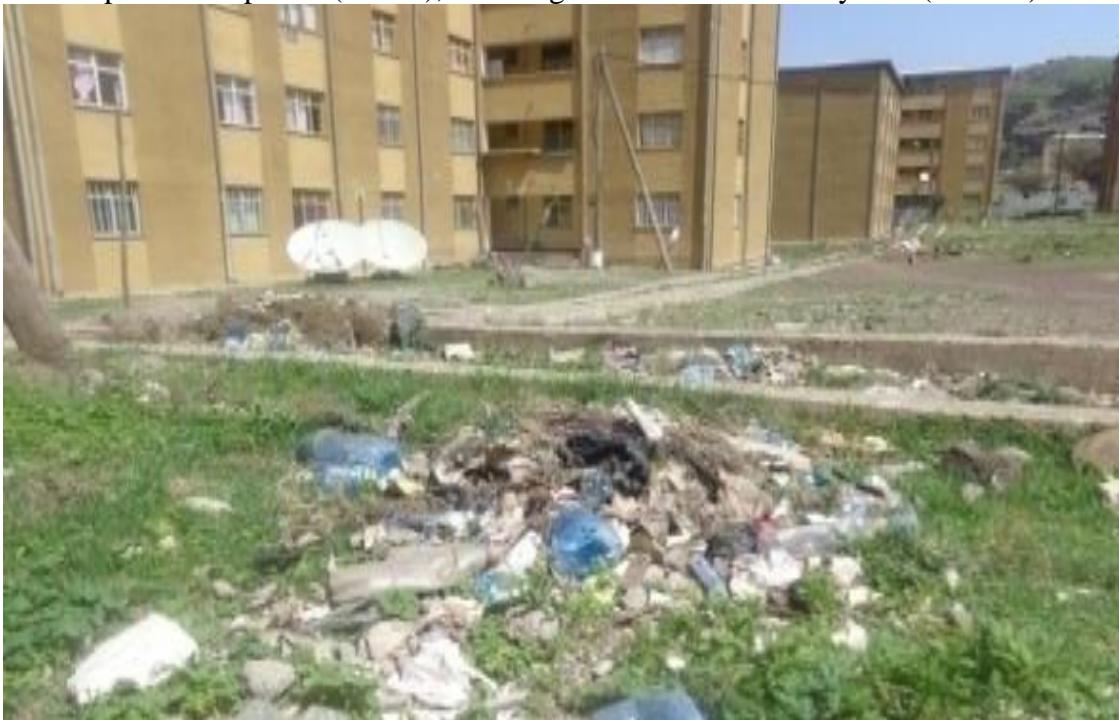
Figure -7: Disposal of solid Waste at Condominium sites

The pictures (Figs. 7, 8 & 9) show neighborhood environmental problems as a result of improper solid waste collection, deposition and disposal, unprotected open space, accumulated liquid waste from a liking septic tank and unclean slaughter house. This is against the provisions stated in Habitat Agenda Goal 1, Indicator 1.11, and ‘access to improved sanitation’. The combined impact of the above conditions adversely affects the health of condominium residents and people in the adjacent neighborhoods as well. The UN-Habitat (2009), Indicators 1.11 and 3.7, Habitat Agenda Goal 5 and goal 11, provide for access to basic services. The same pictures signify insufficient capacity to hygienically separate randomly disposed solid waste, accumulated human excreta from a liking septic system and liquid waste discharged from unclean slaughter house proving the failure to meet both agendas

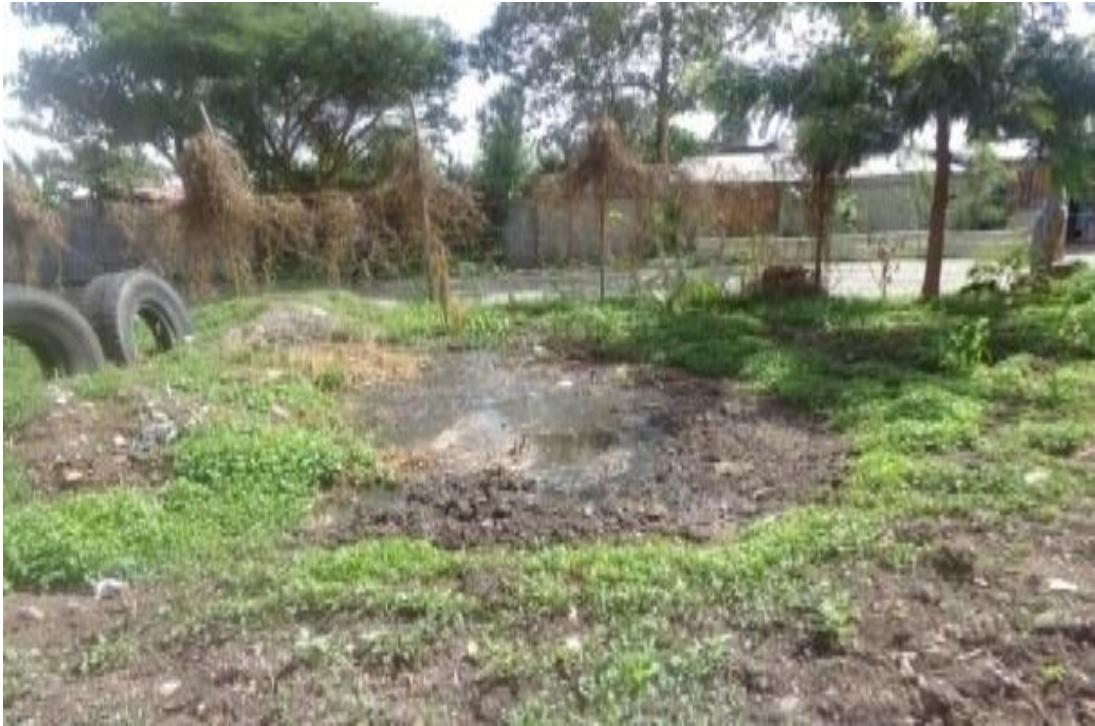
Figure - 8: Accumulated Liquid Waste from Liking Septic tank

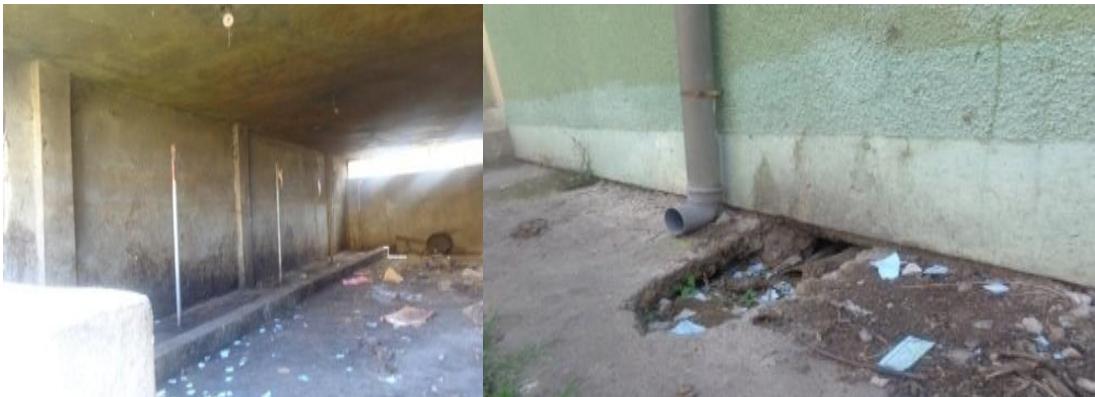
Figure 9: Unclean Slaughter House and Improper Disposal of Liquid Waste from the Slaughter House through a Hole
